Team information

Day 1

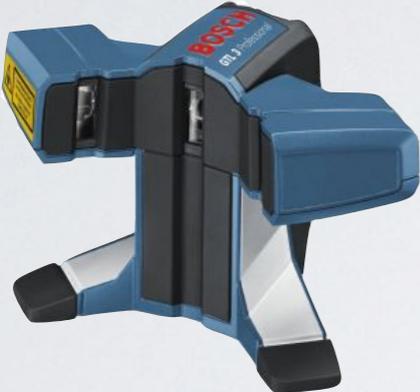
Bosch GTL 3 Tile Laser for stencil application

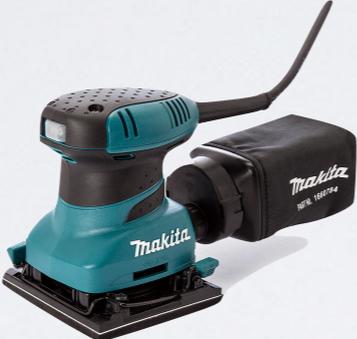
Makita Sander BO 4556

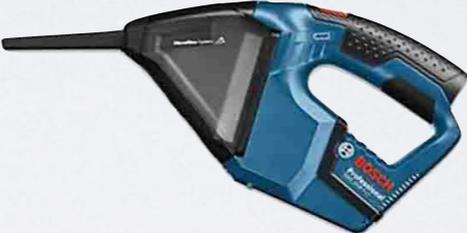
Bosch GAS 12V Cordless Vacuum

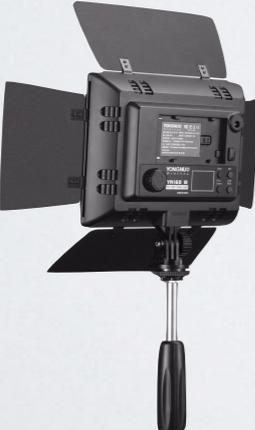
Yong Nuo 3200-5500k video lights

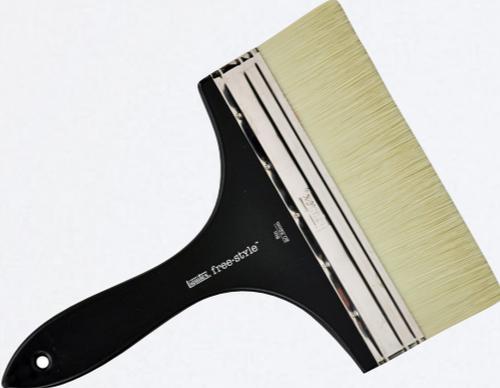
Liquitex XXXL 6'' brush fast & even application, no drips

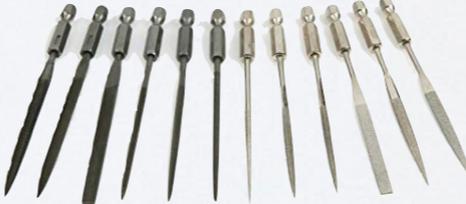
Micro files & rasps

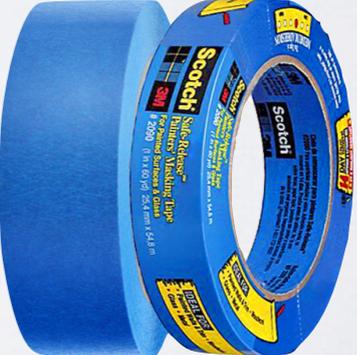
Blue painter's tape

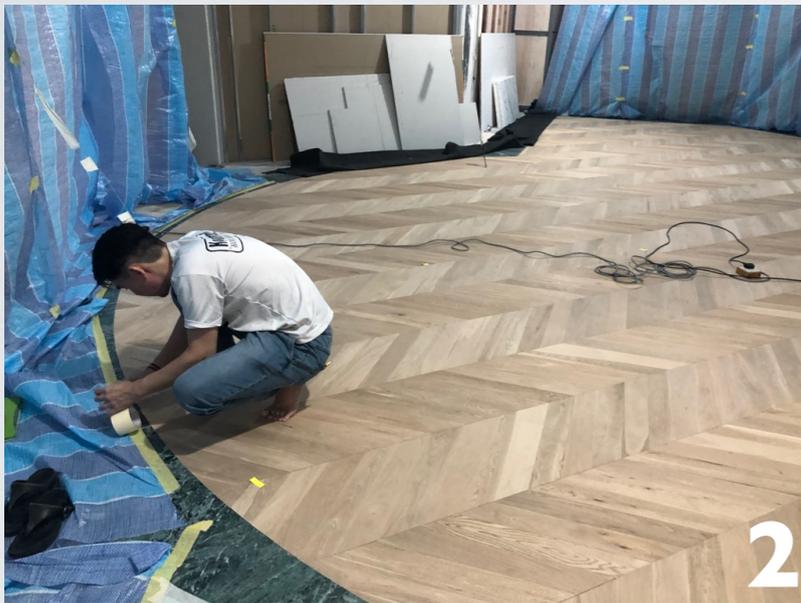
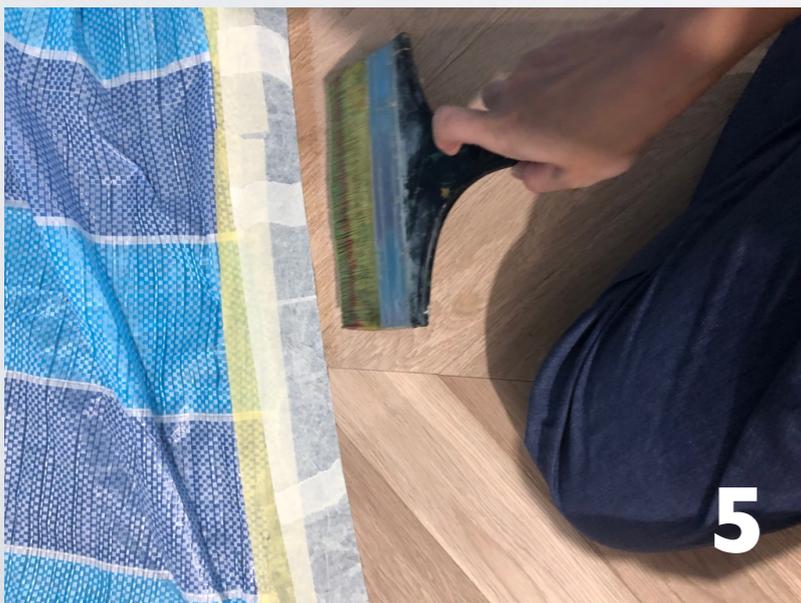
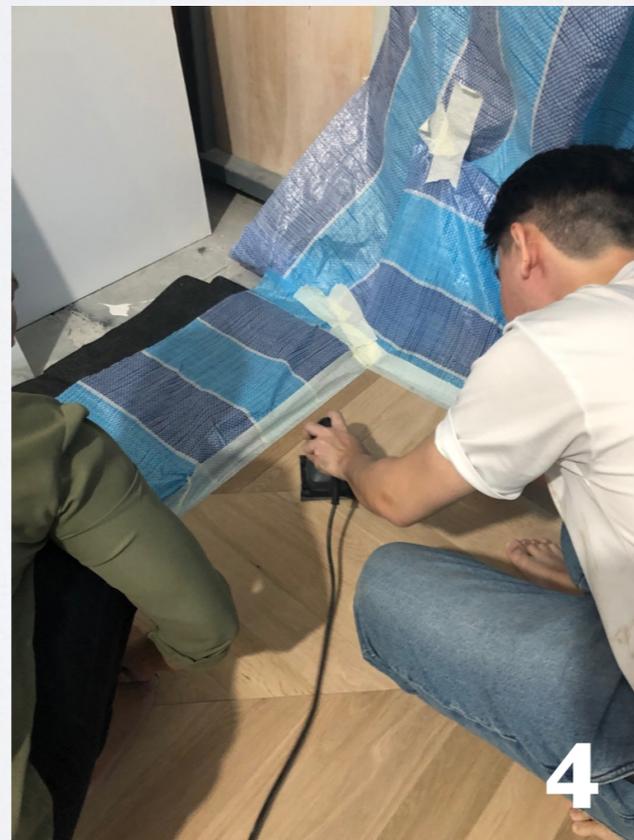
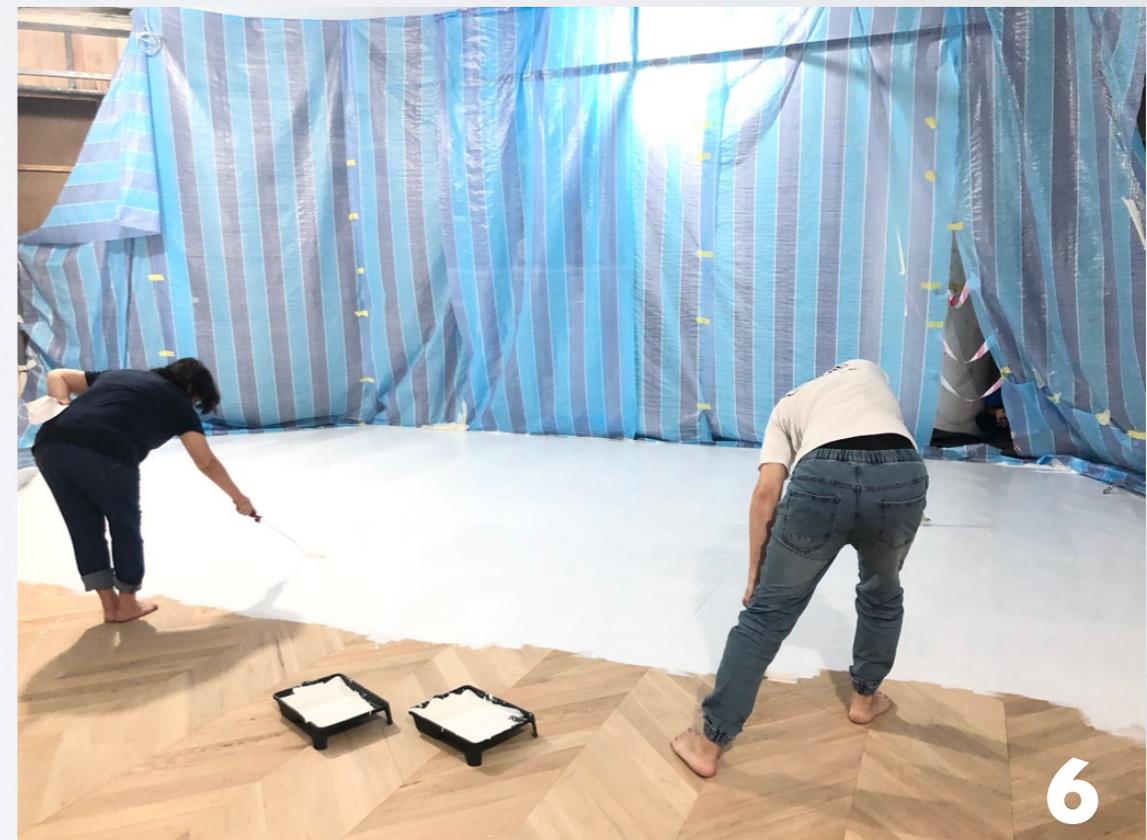
1. General clean up
2. Canvas protection fixing -touching borders and messy **(unexpected)**
3. Border masking
4. Defects - glue drips and uneven installation sanding **(unexpected)**
5. Sealing masking with varnish to prevent bleeds
6. Primer x 3 coats applied consecutively in rows to minimise drying time.

1. Bigger epoxy sponge and longer painting sticks to reduce time spent & increase opacity of primer
2. Site canvas protection not up to requirement, must include minimum 1 ft walkway outside of all borders. No holes and double layers if there's concurrent work.
3. Marble and flooring to be finished with grout & putty

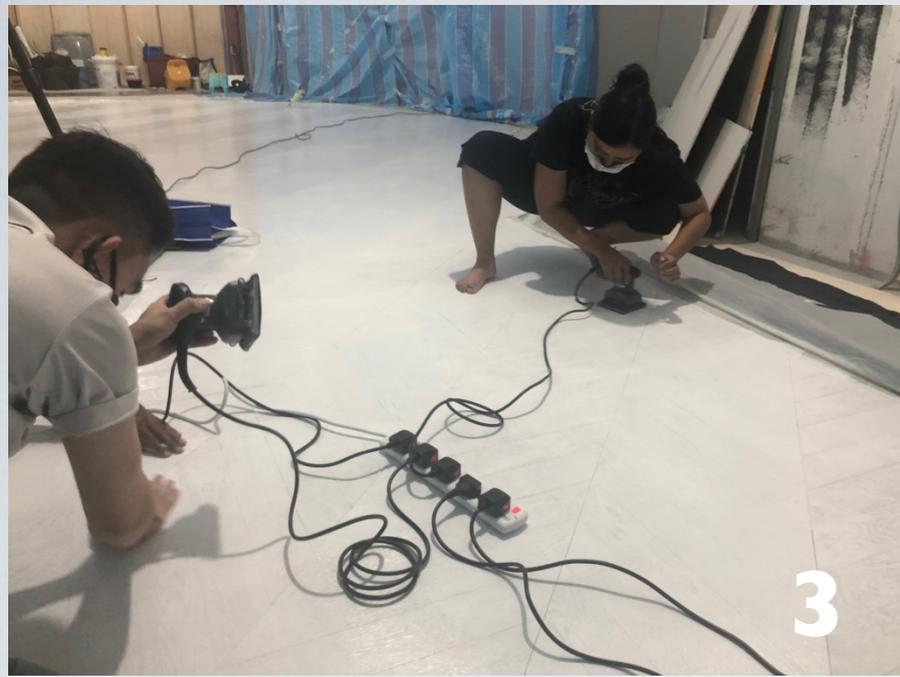
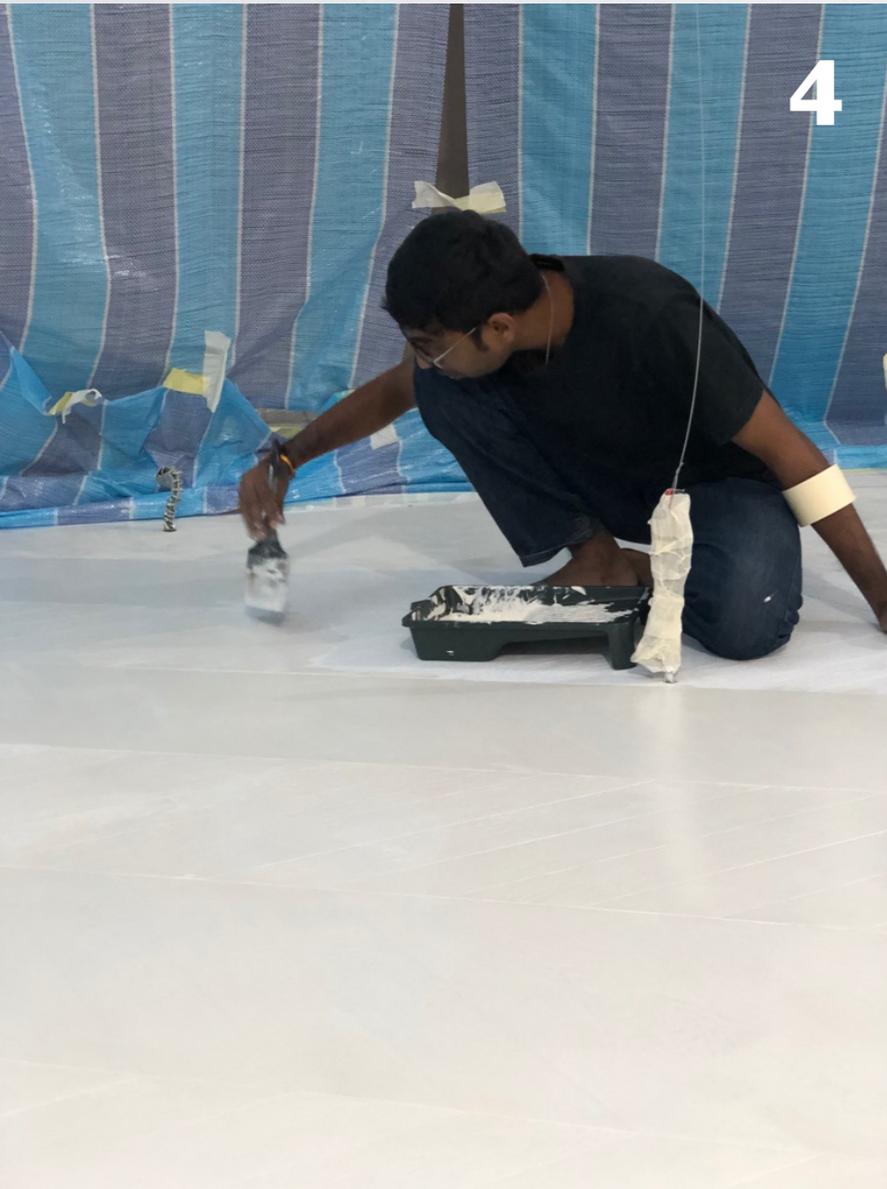
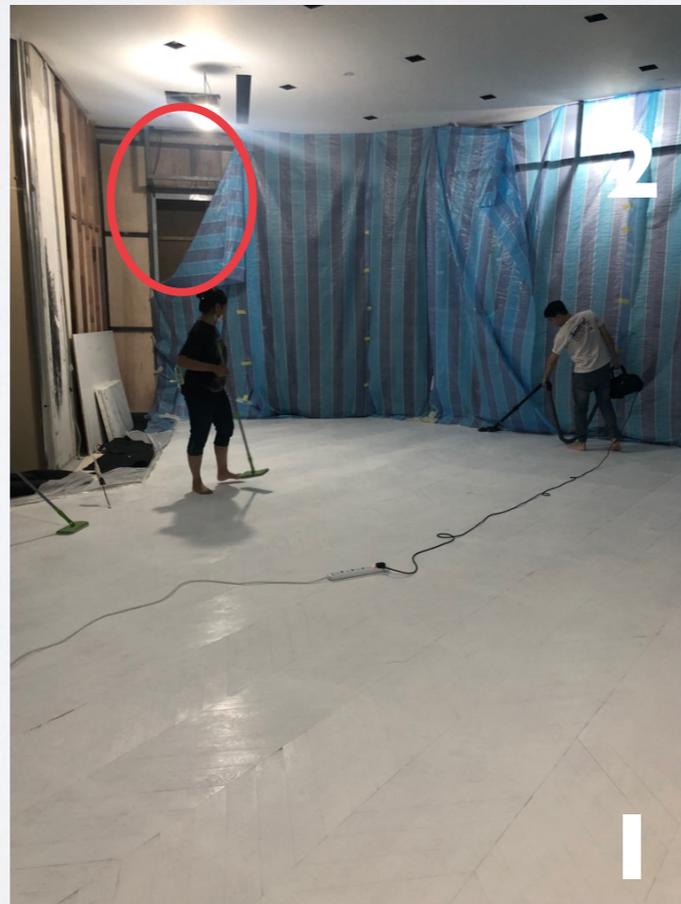
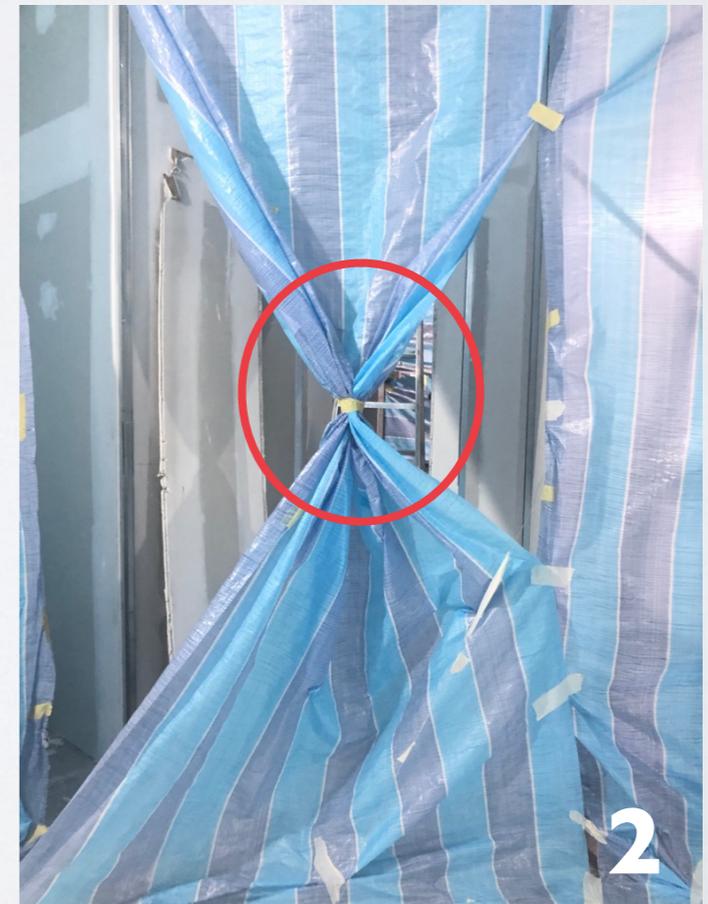
Day 2

1. General clean up
2. Canvas protection fixing - **holes, falling, bunching.**
3. Primer sanding to ensure smooth surface
4. SKK White paint application x 2 layers

5. Site canvas protection not up to requirement. No holes as dust & debris will fall in. Tampering not allowed. Site must be given to us in the same condition we left it.
6. Bigger sanders for sanding
7. White paint application require 4-5 spotlights to ensure consecutive painting to eliminate in between drying time.
8. White paint to be exposed in order to thicken, allows for more opacity in less layers.

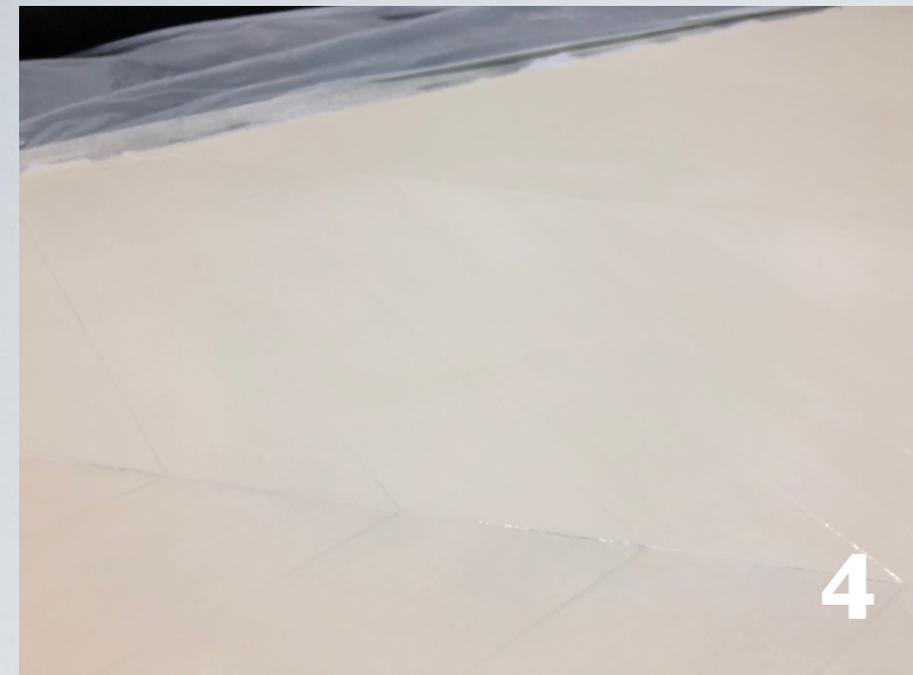
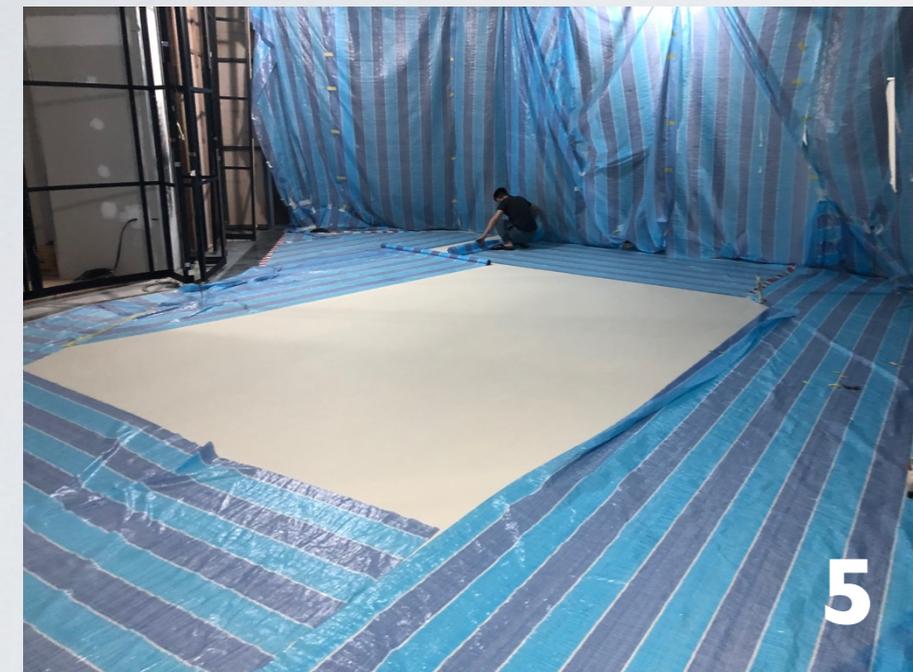
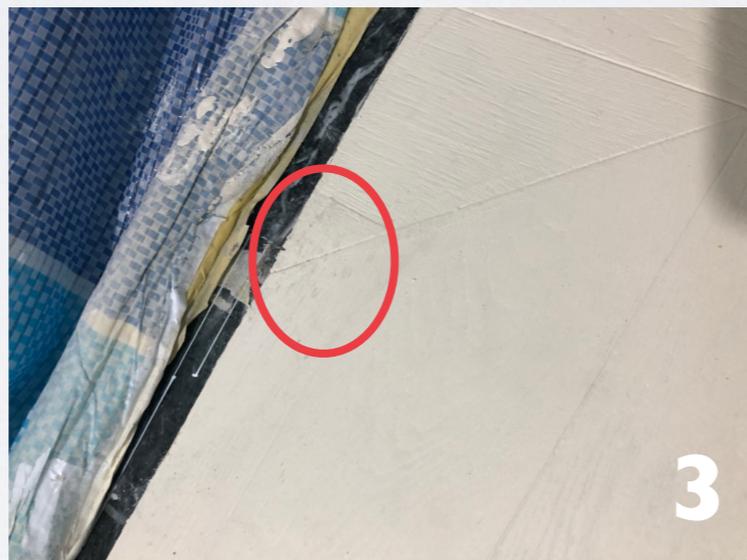
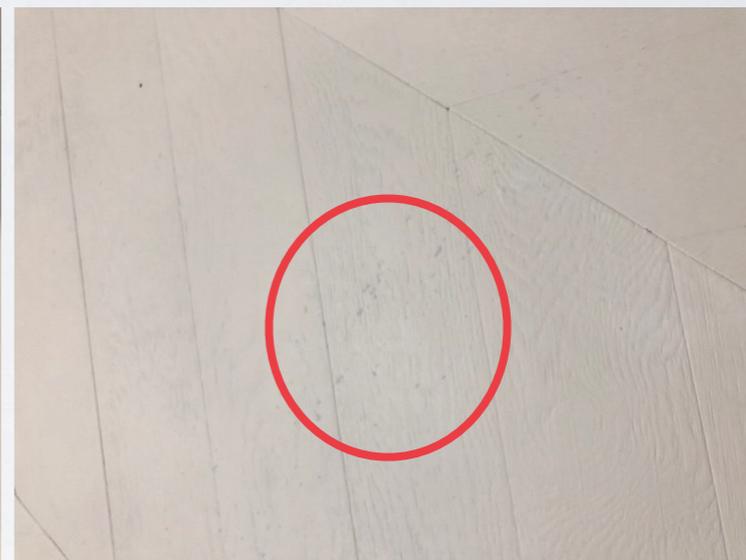
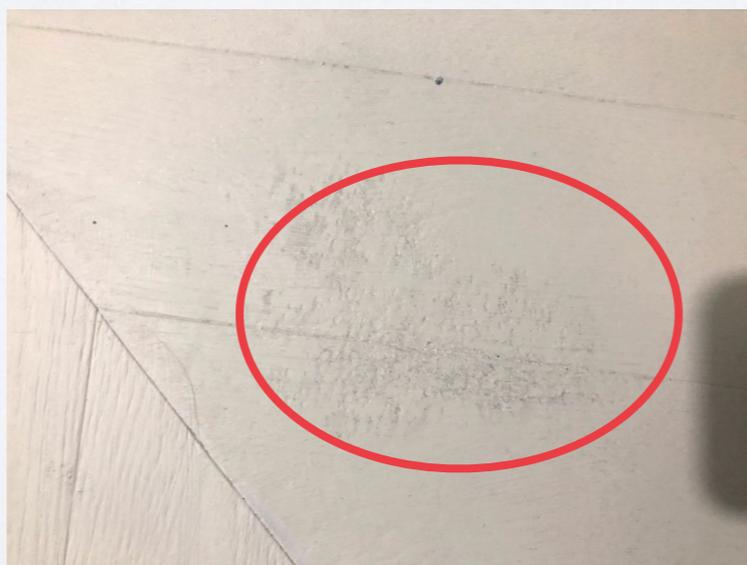
Day 3 - (delay)

1. General clean up
2. Canvas protection fixing - **(unexpected)**
3. Defects fixing caused by yesterday's after work **(unexpected)**
4. SKK White paint application x 1 layer
5. Floor protection to facilitate after work **(unexpected)**

6. Concurrent/after work can be allowed if good faith is returned - site & canvas protection not returned in defects
7. White paint application to be done in 2 days and not 1.
8. White paint application require 4-5 spotlights to ensure consecutive painting to eliminate in between drying time. This may reduce days of work, TBD.
9. Concurrent work cannot be executed in areas where the paint is still wet or when floor protection is absent

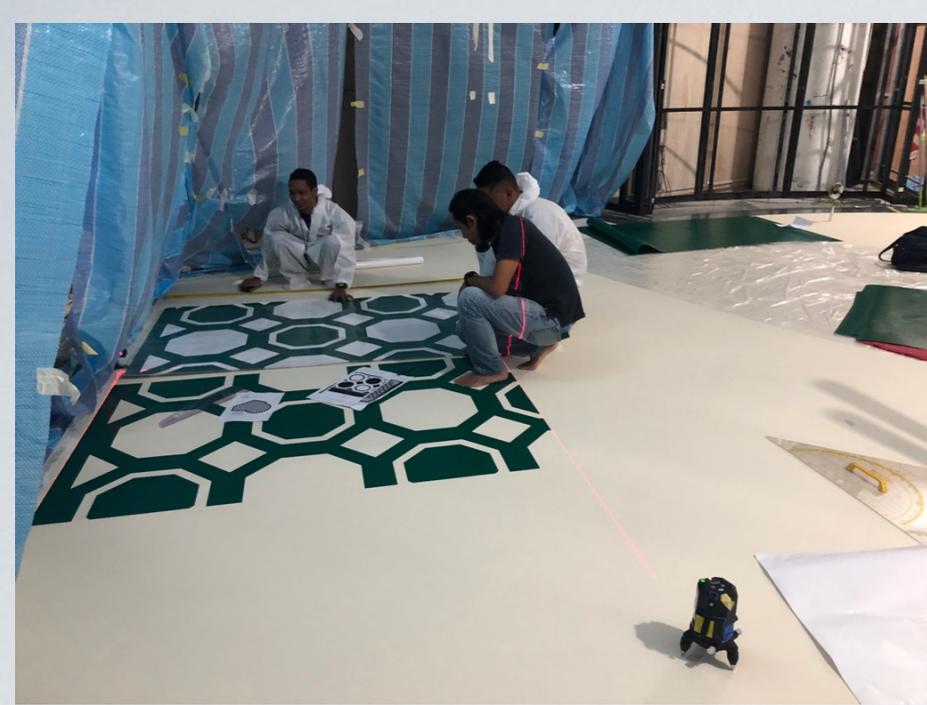
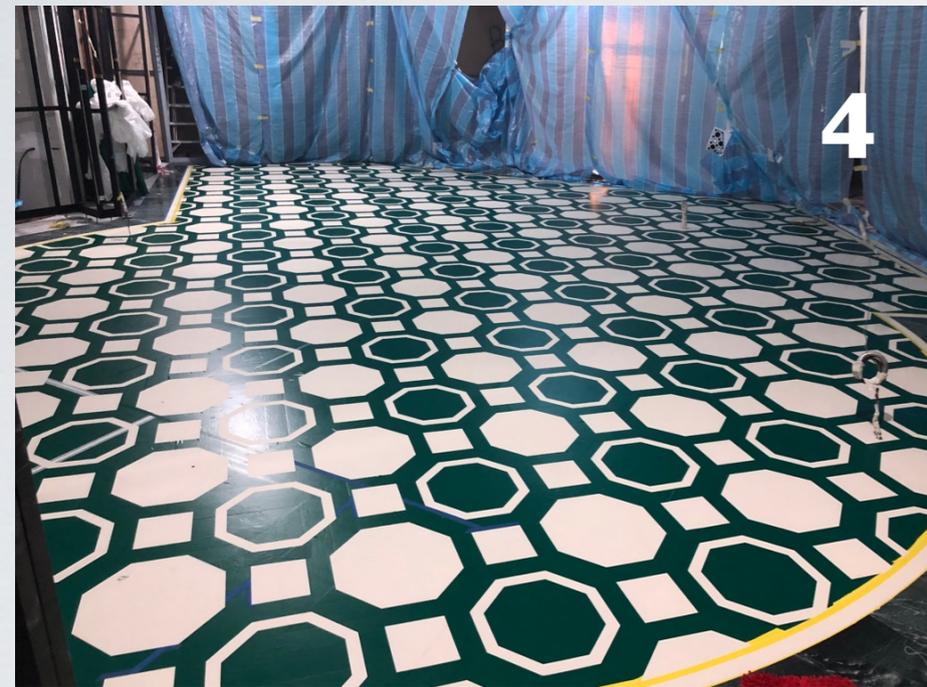
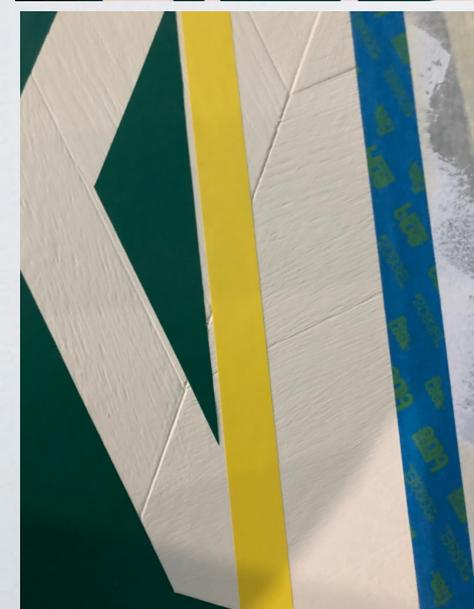
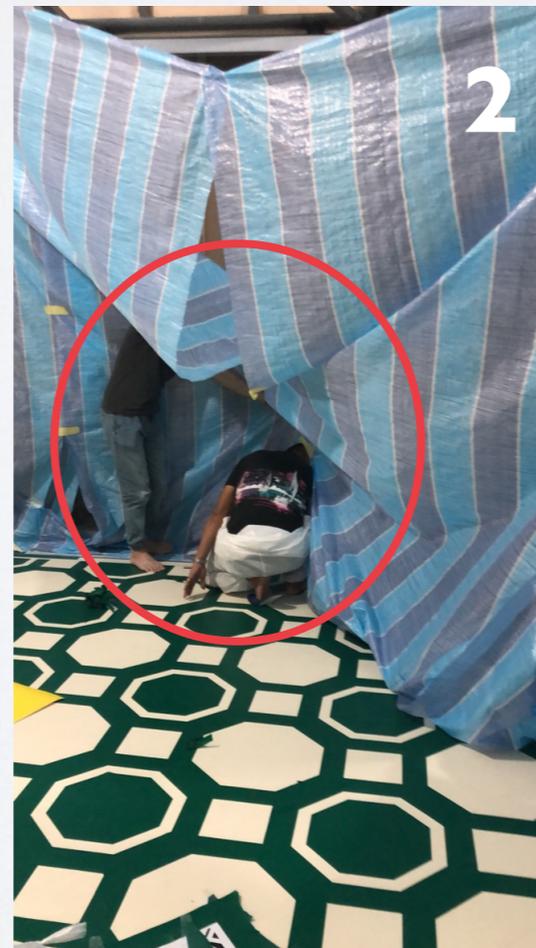
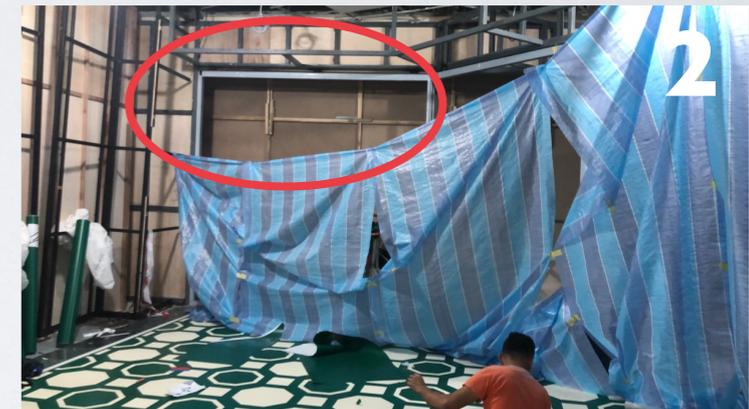
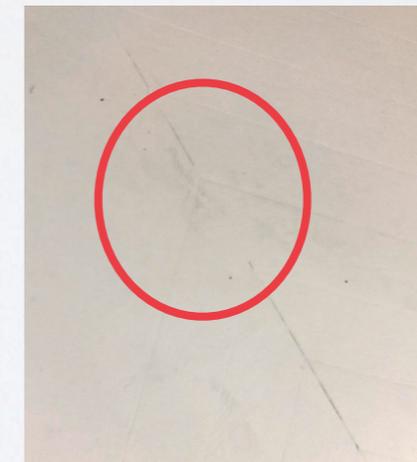
Day 4

1. General clean up
2. Canvas protection fixing - **(unexpected)**
3. Defects fixing caused by concurrent/after work- **(unexpected)**
4. Stencil application, 8 installers worn protective suits & slippers provided by us.

5. Site canvas protection **completely unacceptable.**
6. Defects caused by concurrent work causes delays
7. 3M protective suits must be worn by all installers to avoid dirtying the floors. More to be provided.
8. **Dust & rubble** of concurrent work fell on floor, causing bubbles in stencil application. Boundaries need to be enforced strictly.
9. Sticker type to be changed to automotive sticker brand Oracal.
10. Borders to be installed first, followed by pattern for easier workflow.
11. All edges must be heat gun flat over creases and wood profile
12. Installers requested for **2 day installation**

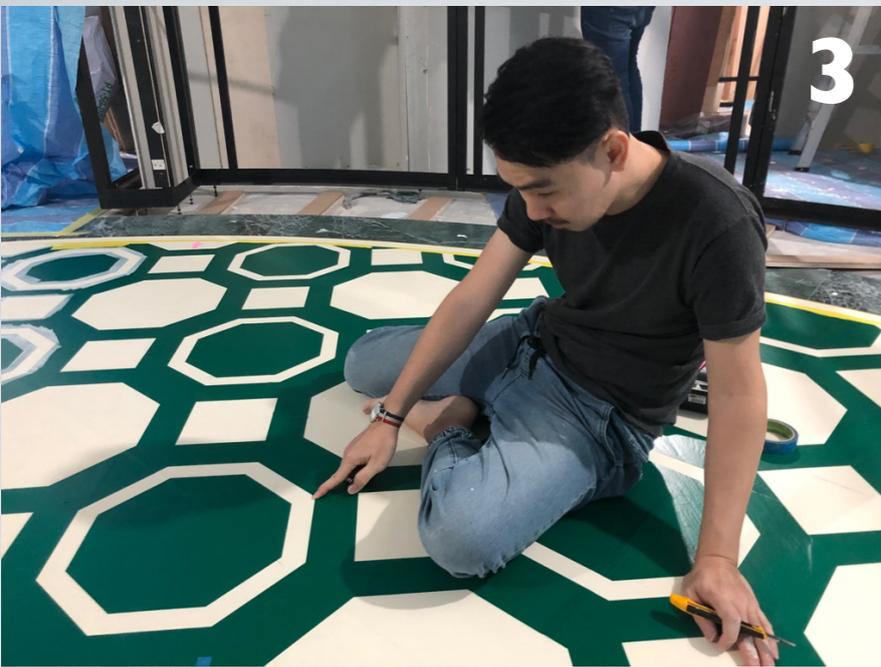
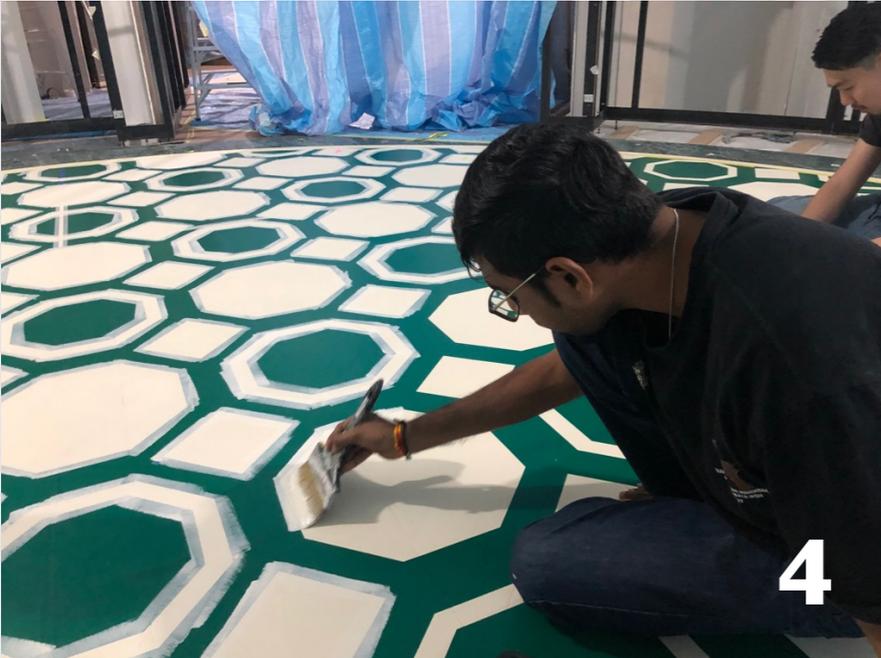
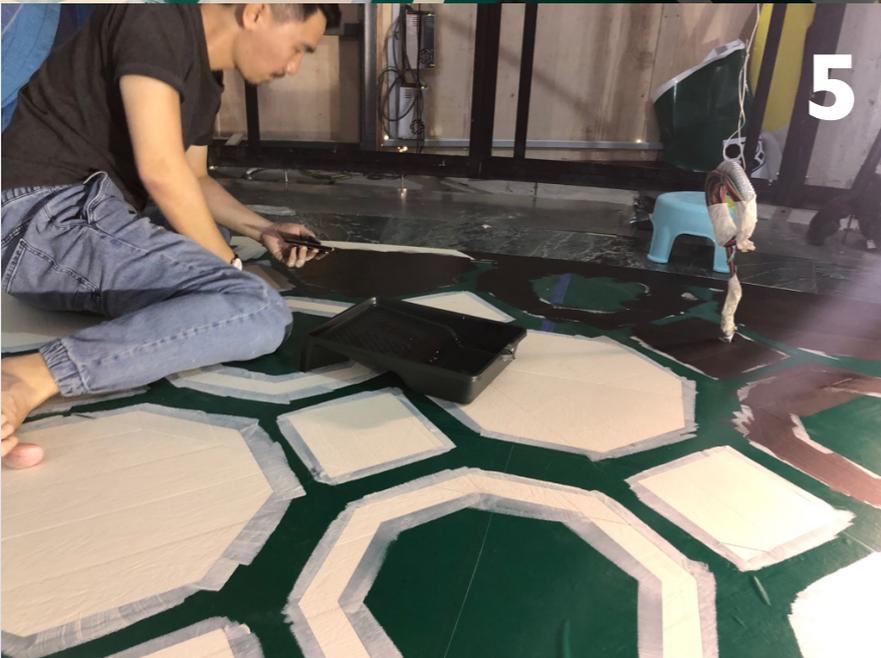
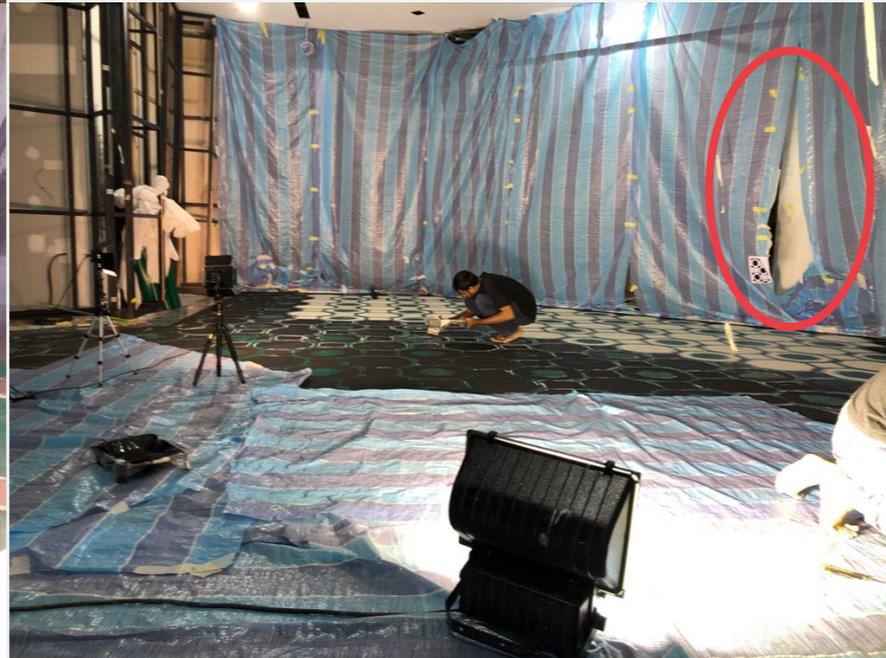
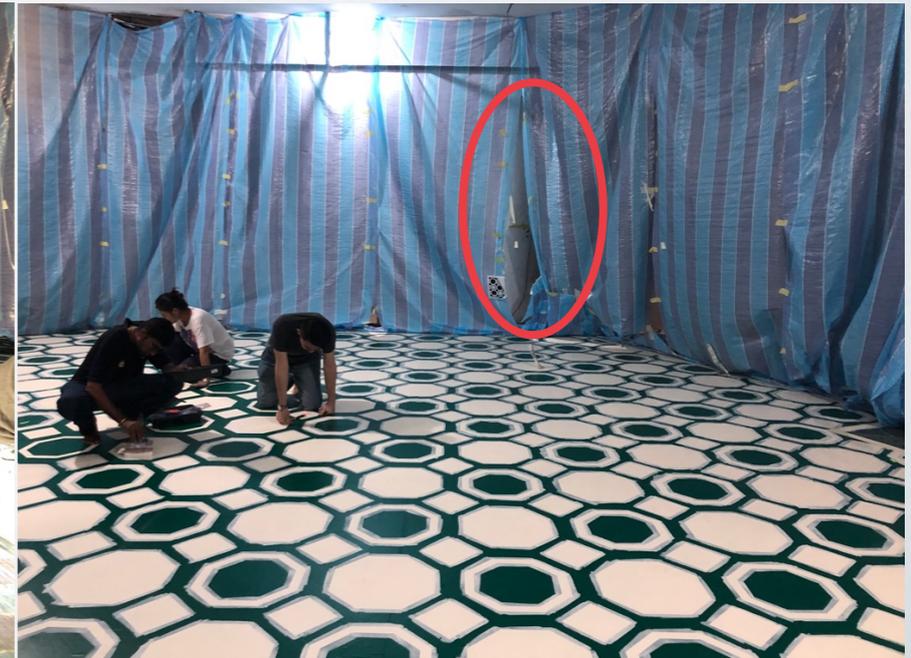
Day 5

1. Canvas protection fixing - **(unexpected)**
2. Checking stencil, burning bubbles in, removing rubble and debris from below stencil
3. Painting white over edges to seal stencil and reduce bleeding
4. Painting black x 2 layers, facilitated by 3 spotlights for consecutive painting without in between drying time
5. Touch up black 1 layer.

6. Site canvas protection completely unacceptable.
7. Defects caused by concurrent work causes delays
8. Spotlights of high temperature speed up work exponentially.
9. Good day for concurrent work
10. **Lack of electricity** causes work to start without cleanup, lights to arrive too late. Extension was locked in a GC's box

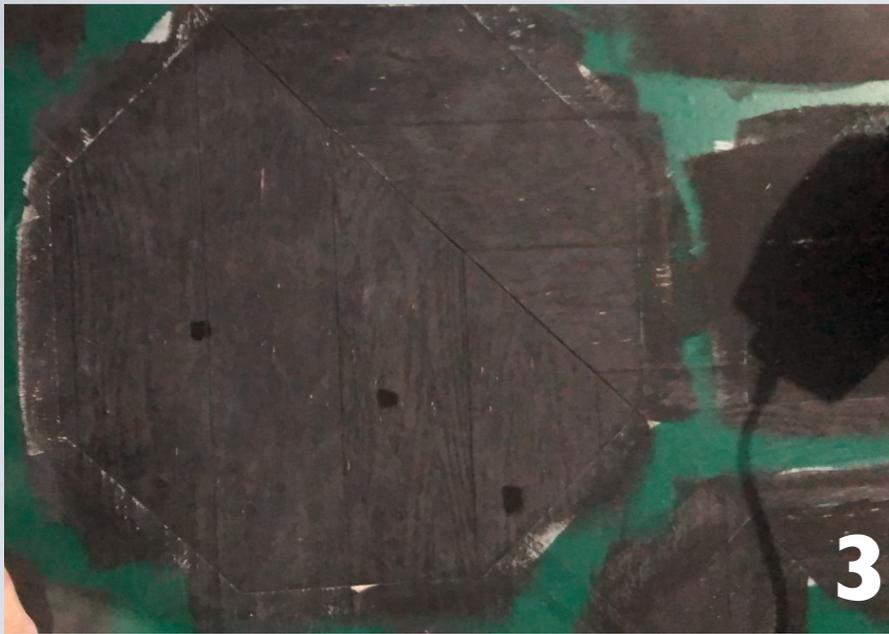
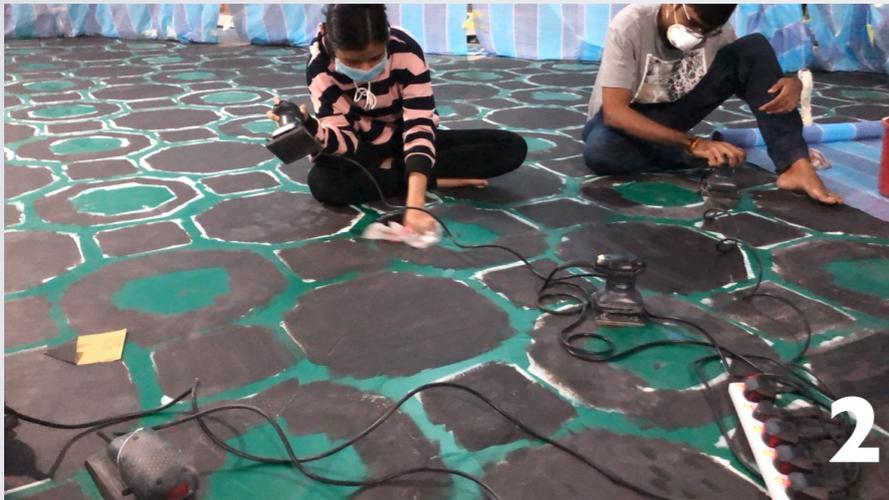
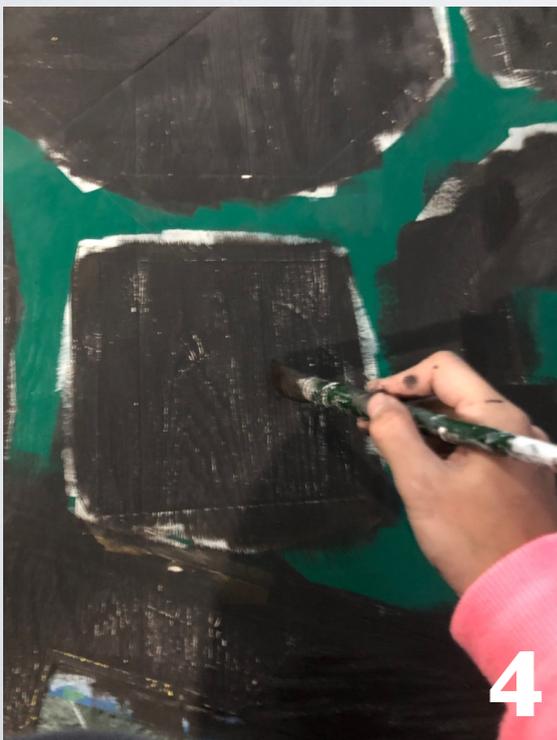
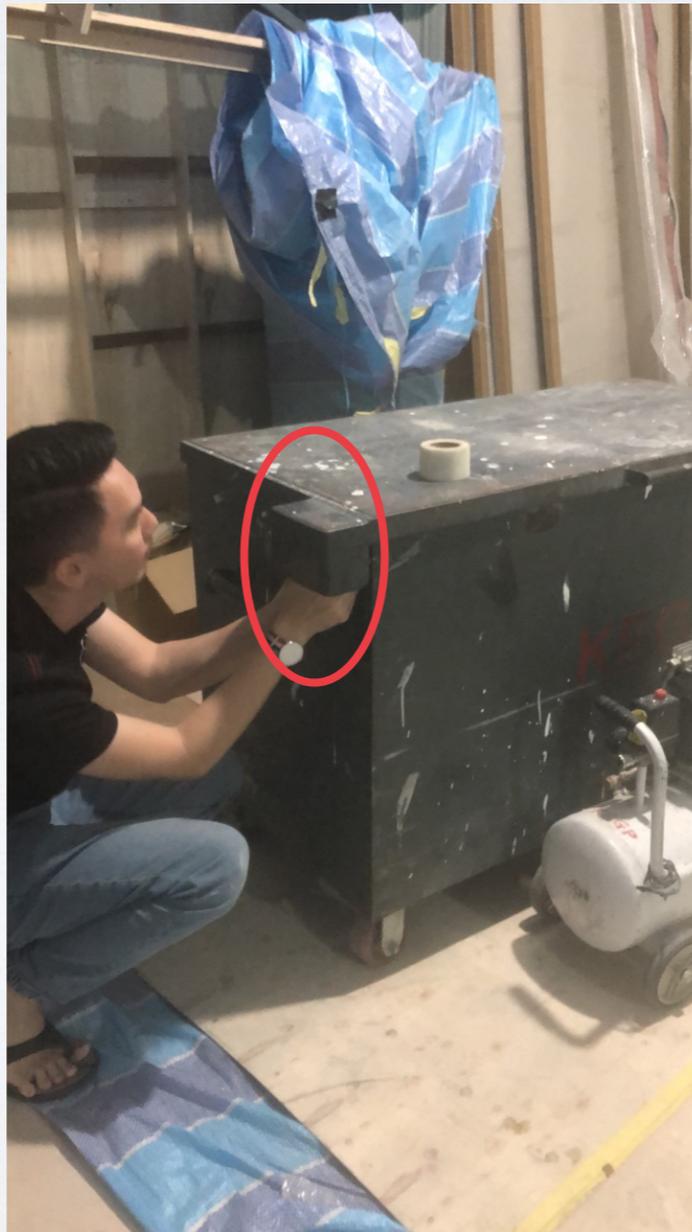
Day 6

1. General clean up
2. Sanding with 360, 240 & 180 grit. 240 recommended, wiped with water to check effect.
3. Sanding is approved by HK.
4. Touch up with black to ensure good distribution & composition of sanding.

5. **Lack of electricity** causes delay again even after reminding. Extension was locked in a GC's box
6. Workers not allowed to change to lower grit to speed up process.
7. Good day for concurrent work

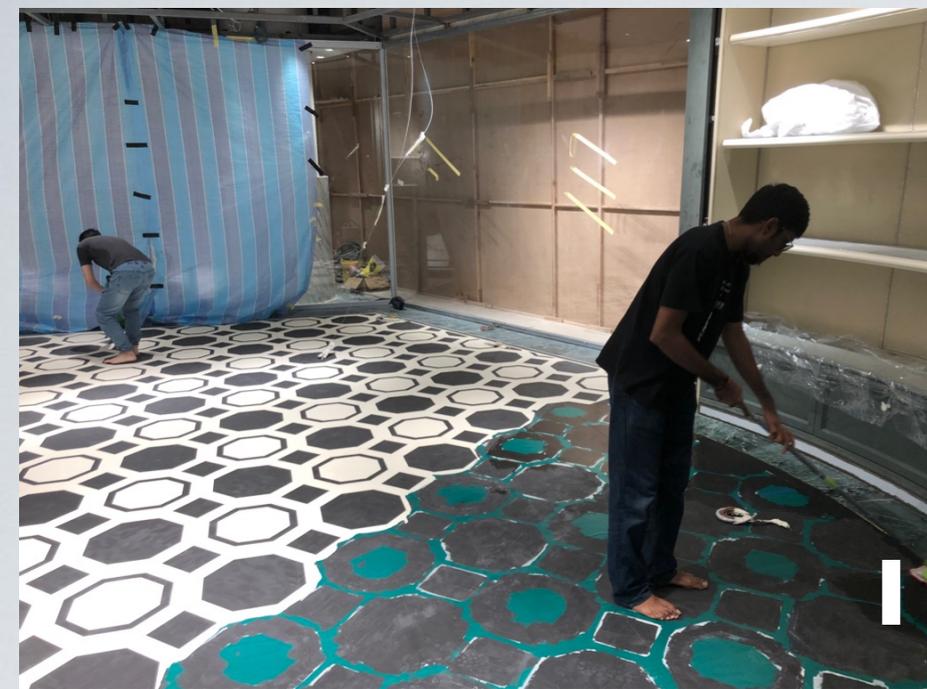
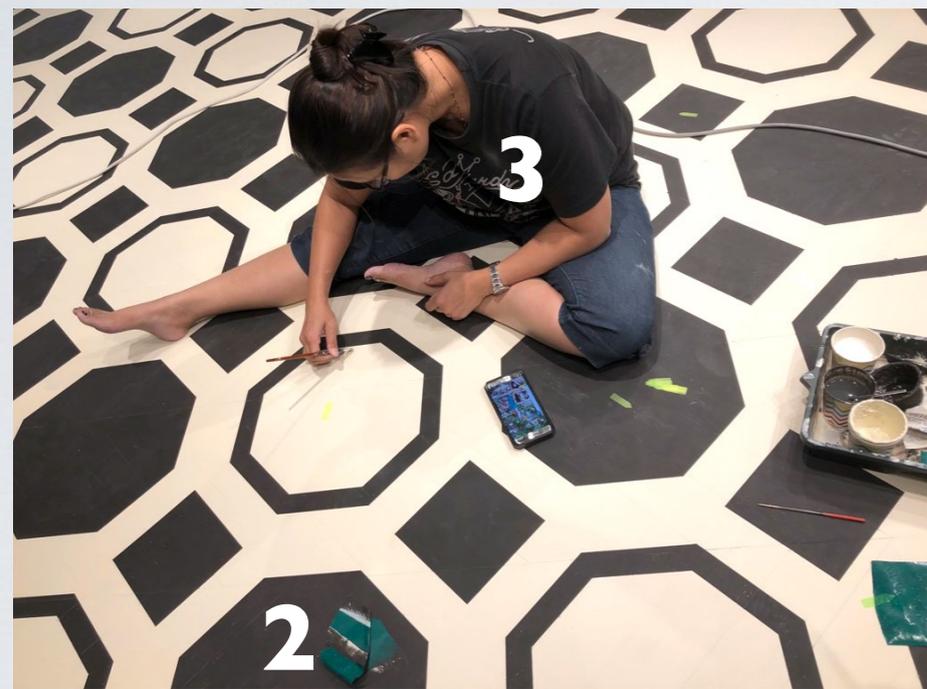
Day 7

1. Thorough vacuum and wet wiping over black & decal to ensure black sanding does not dirty white when decal is removed.
2. Thorough clean insufficient as dust and debris were caught on canvas protection, leftovers stencil used to stick up dust & debris
3. Retouching bleeds, sanding and ensuring each shape is aesthetically pleasing.
4. Stencil is removed as touch up progresses.

6. Extension was locked again. Tools to be changed to cordless to avoid this issue altogether in future jobs. I.e- Vacuum, sander & lights.
7. Sticker choice for stencil to be changed to Oracal to reduce bleeds for future jobs.
8. Partial removal of stencil is good for facilitating concurrent work for areas with high work traffic.
9. **Ran out of 3m protective suits today.** Suit not required today but due to dusty environment, suits were worn today resulting in lack of suits for top coat day.

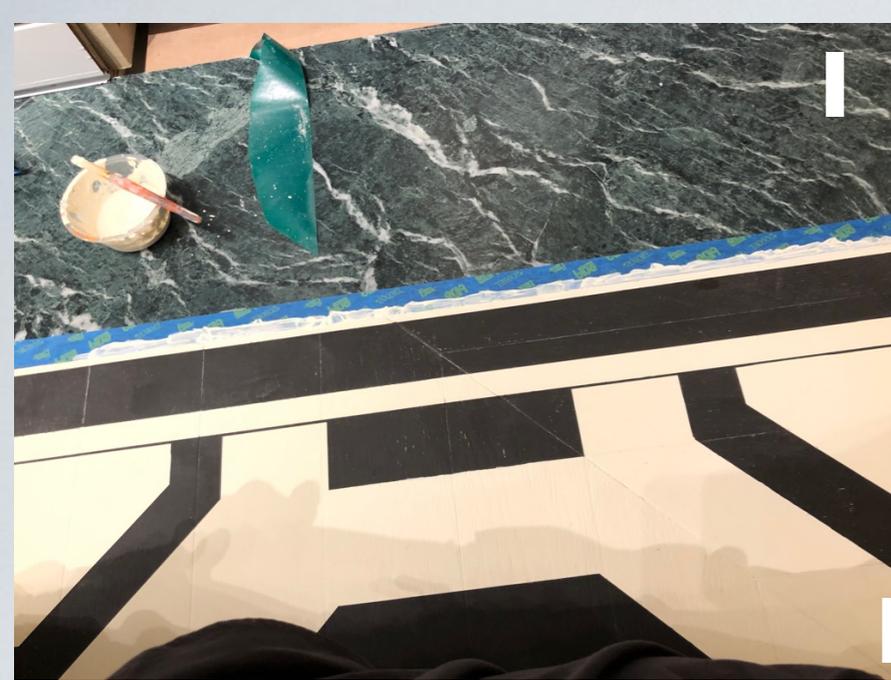
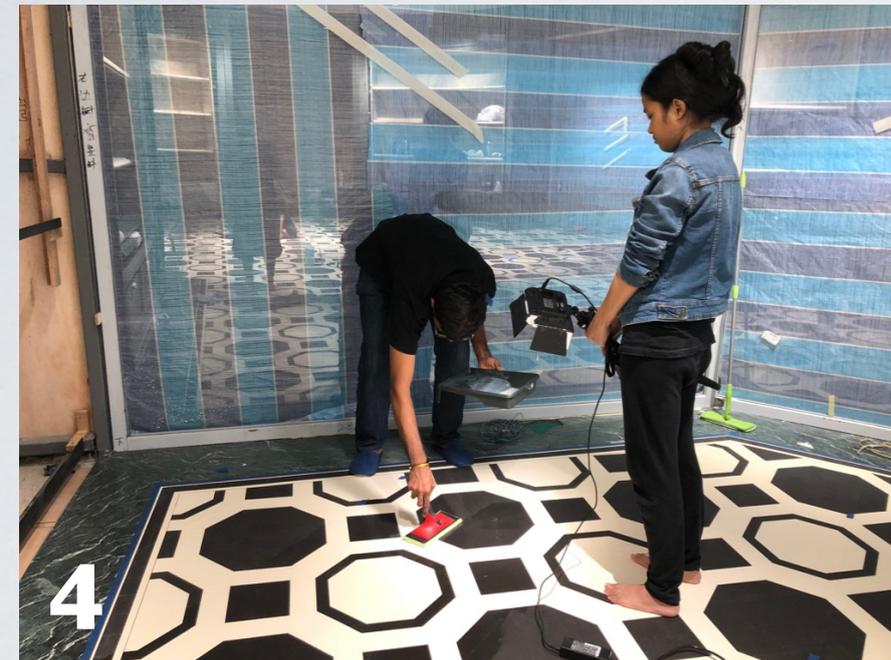
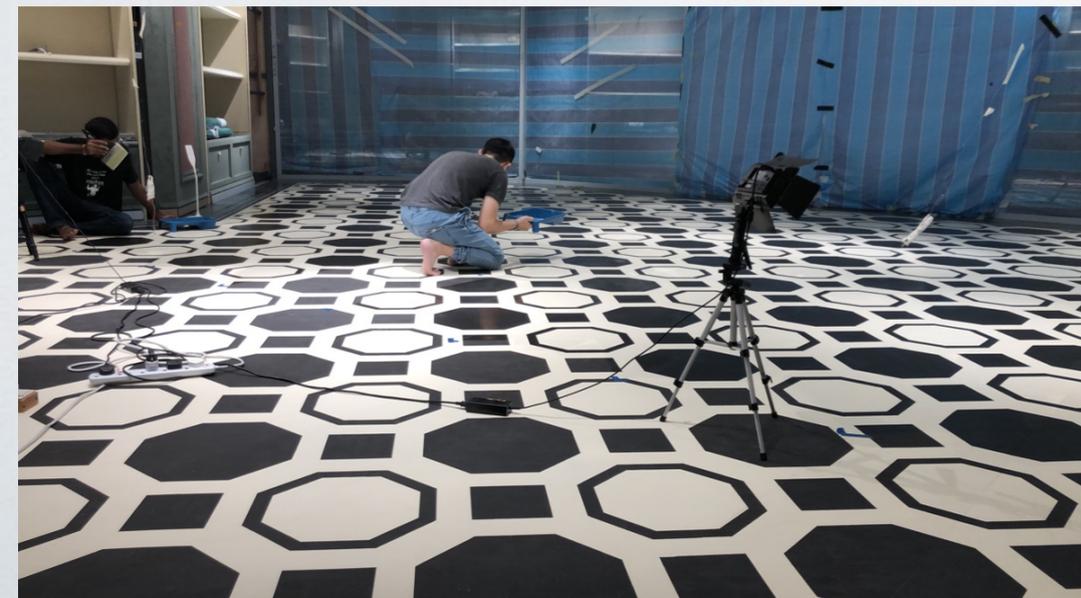
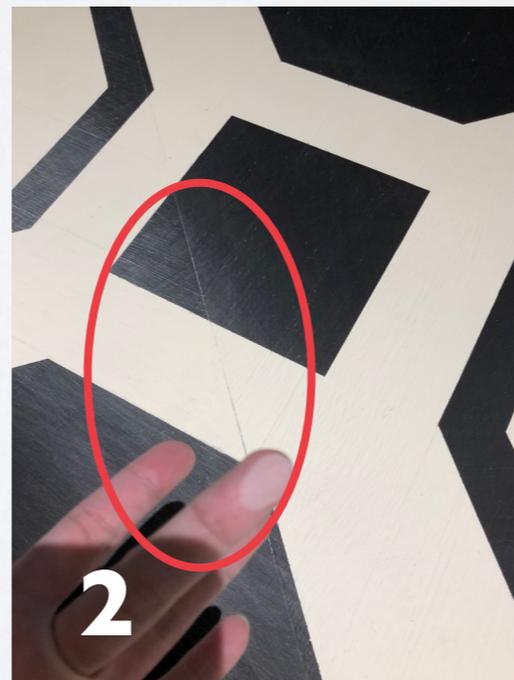
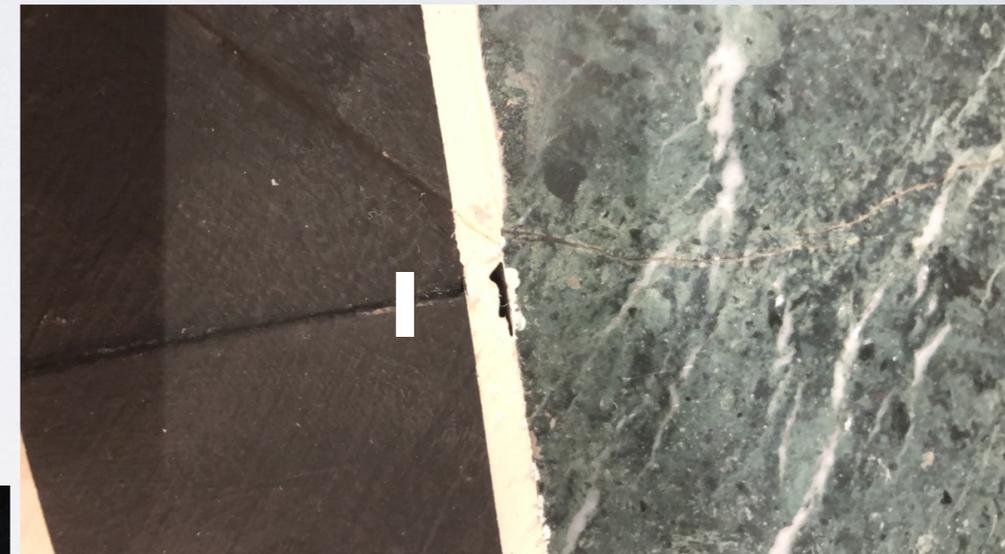
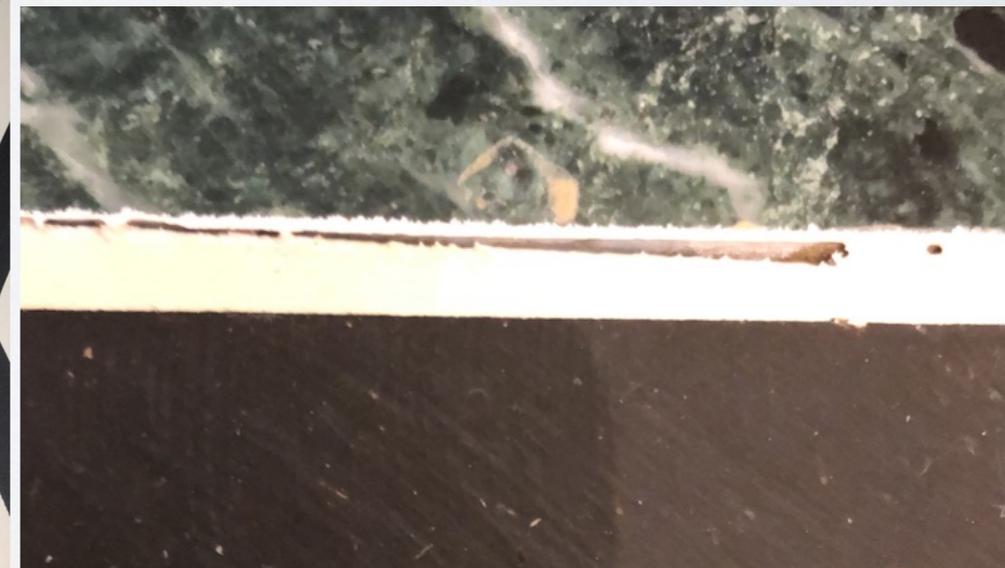
Day 8

1. -continue- Retouching bleeds, sanding and ensuring each shape is aesthetically pleasing. Marble & border retouching with putty.
2. Clean up due to defects and dirt build up from previous night's concurrent work.
3. Thorough vacuum, dust removal for top coat preparation
4. Top coat sieved into new clean paint tray, paint brush cleaned and dried between coats. Top coat is applied with high temp spot lights to facilitate fast drying & even application.

5. Large size foam brush to be custom made to speed up this process for next job. Also, to reduce kipple from gathering between normal paint bristles.
6. More spotlights needed.
7. Area must be completely sealed, air pockets must be sealed and observed carefully in case of concurrent work.
8. GC's work involving drilling & cutting must be vacuumed as they work.
