Team information

Day 1

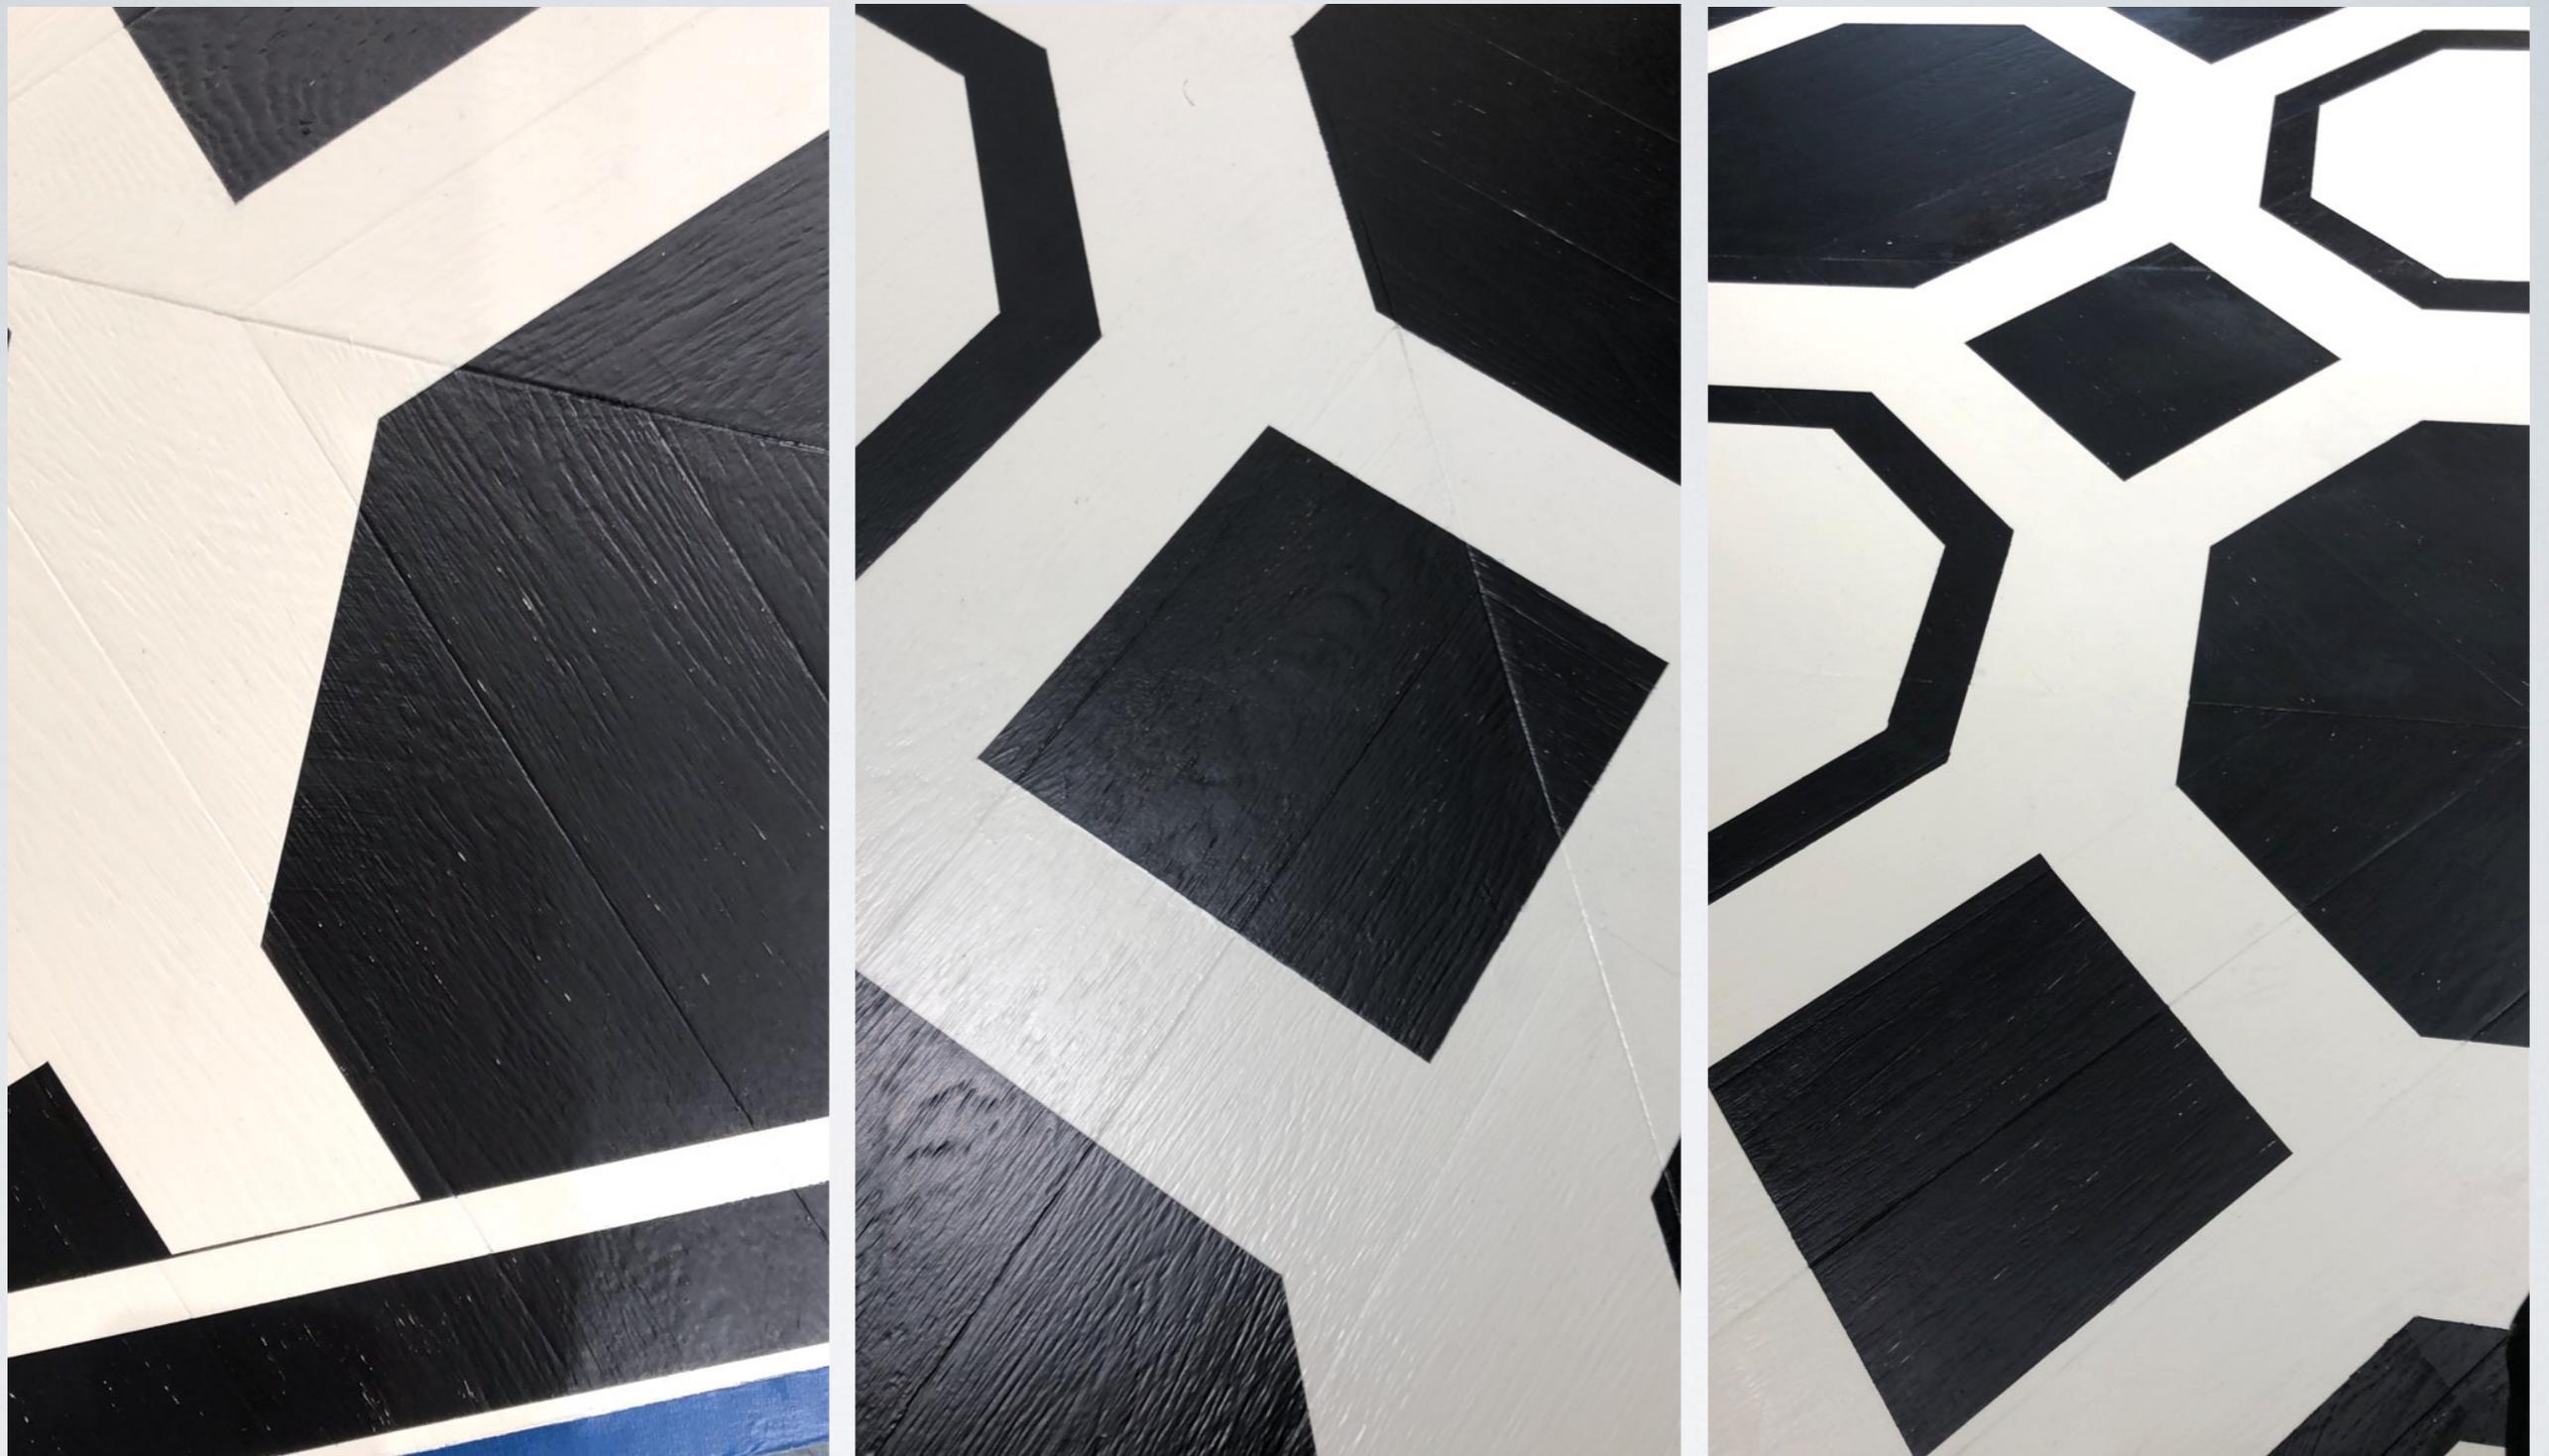
Handover condition

Instructions given to GC - Light foot traffic on first night with complete floor protection
Waterbased PU top coat susceptible to scratches, heavy and destructive methods must be avoided.
Top coat cures hard in 7 days, will remain soft until cured. Careful workers recommended.
